# PERAK HERITAGE MOSQUES: EVALUATING THE DEFECTS OF BUILDING ELEMENTS

**Kartina Alauddin<sup>1</sup>, Mohd Fisal Ishak<sup>2</sup>, Muhammad Azim Muhamad Wazir<sup>3</sup>**  
*123Universiti Teknologi MARA, Seri Iskandar Campus, Seri Iskandar, 32610  
Perak, Malaysia*

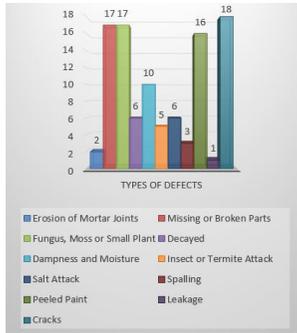
Figure 1. Defects of Heritage Mosques in Perak

Figure 1 shows the percentages of defects that exist at the five heritage mosques. The types of defects are cracks, growth of fungus, moss or small plants, have some missing or broken parts, peeling paint, dampness and moisture, salt attack, decay, insect or termite attack, spalling, erosion of mortar joints, and lastly leakage. The defect that has the highest percentage is cracked constitute about 18%, while the defect that has the lowest percentage is leakage with 1%. Based on the result of observation obtained, defects of heritage mosques in Perak are mainly cracks.

Most of the defects that happened in heritage buildings are cracks. Based on the observation made, the findings showed that all heritage mosques selected have cracks defect. Cracks are often caused by the pressure of excessive load either it is live load, dead load and wind load to the building. It can become serious with the aging of the building. Due to aging, the building strength will reduce because the frame of the building is dilapidated. The heritage mosques are mosques that had long been built and the defect of cracks can be easily seen in the element of building on the mosques. The lowest case of defect that can be found in the heritage mosques is leakage defect. Leakage defects can occur in the heritage mosques, but these defects do not occur frequently. Leakage defect often occur where there is a cracked water passage, broken or missing part of elements, decay and so on. It happens if there is water in the passage. In addition, leakage defect is rarely being found in the heritage mosques because not all elements of the building are involved with the passage of water.
